Aerials and monitoring locations Bayou Corne Sinkhole

Bayou Corne Sinkhole area

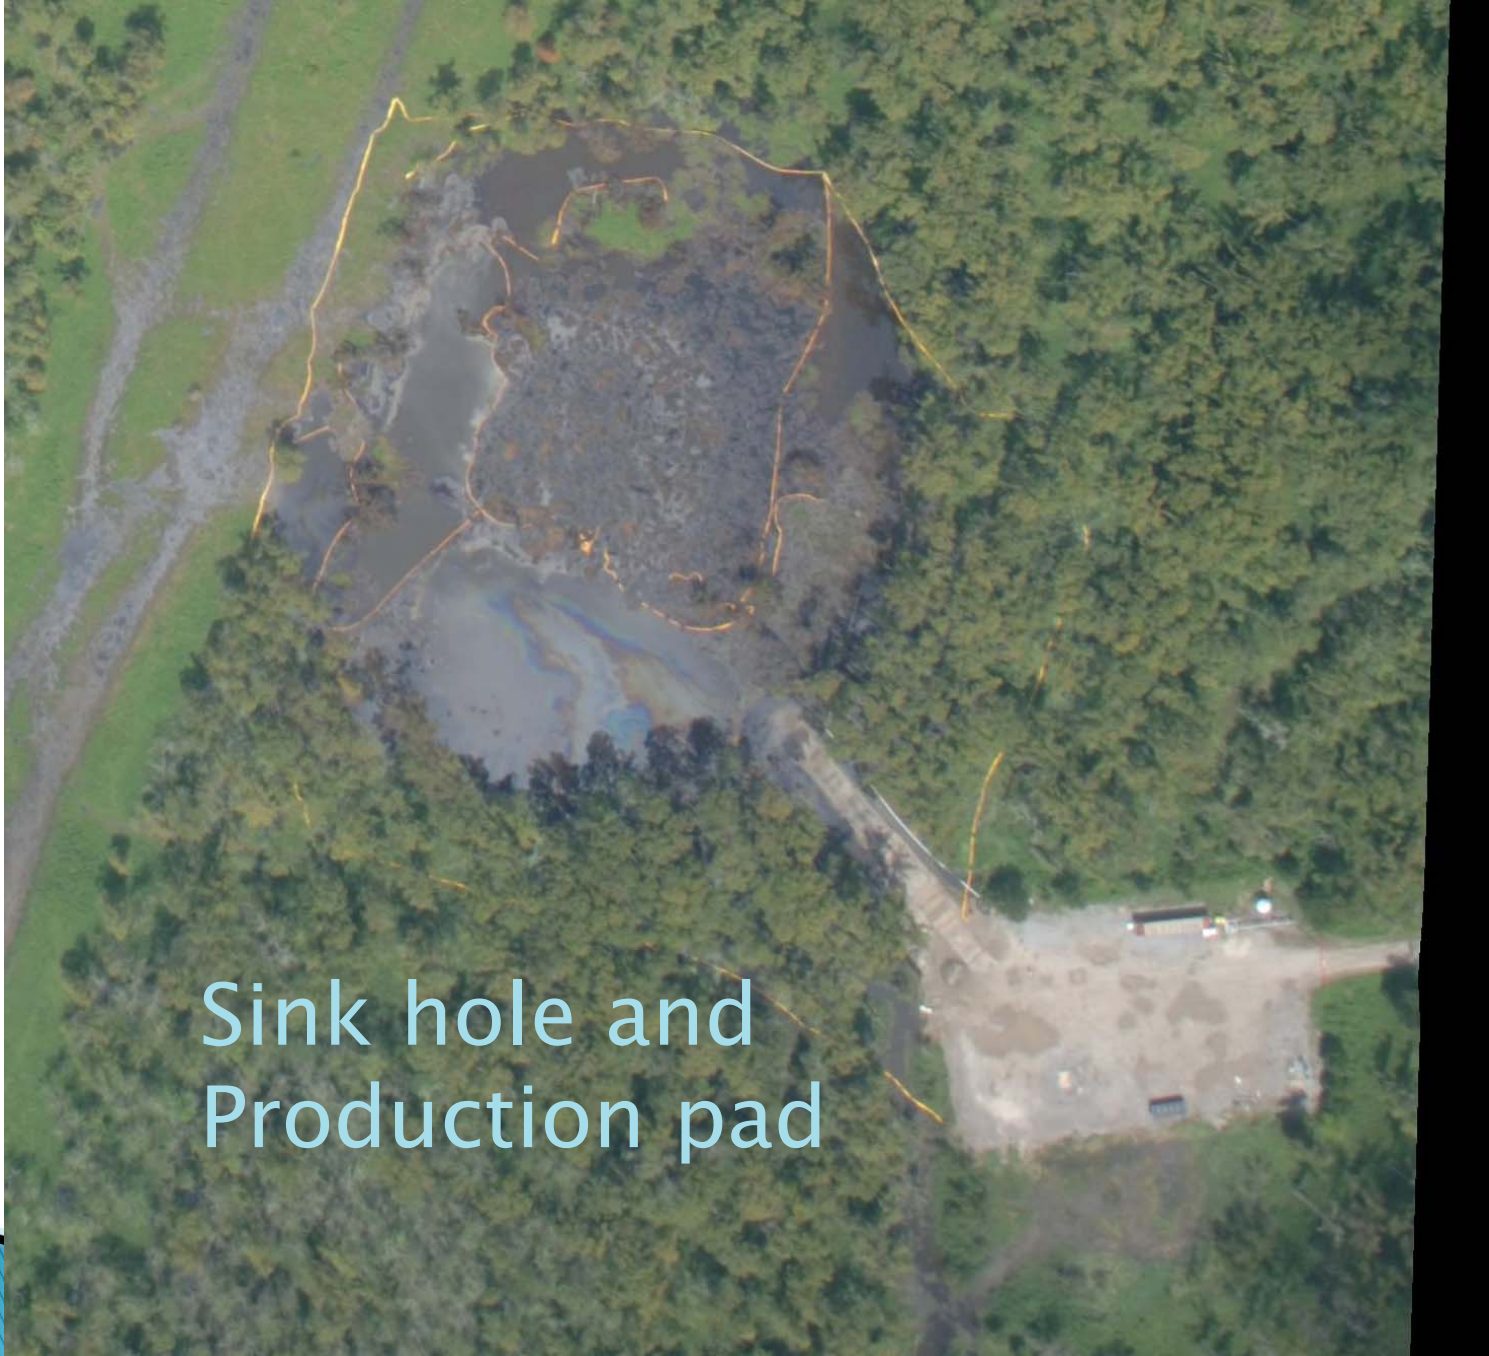
Sink hole and
Production pad

An aerial photograph showing a large, irregularly shaped sink hole in a forested area. The sink hole is filled with dark, murky water and has a yellow boundary line drawn around its perimeter. To the right of the sink hole is a cleared, light-colored area labeled as a 'Production pad', which contains some industrial equipment and a small building. The surrounding area is covered in dense green trees and vegetation. A blue and black decorative graphic is in the bottom left corner.

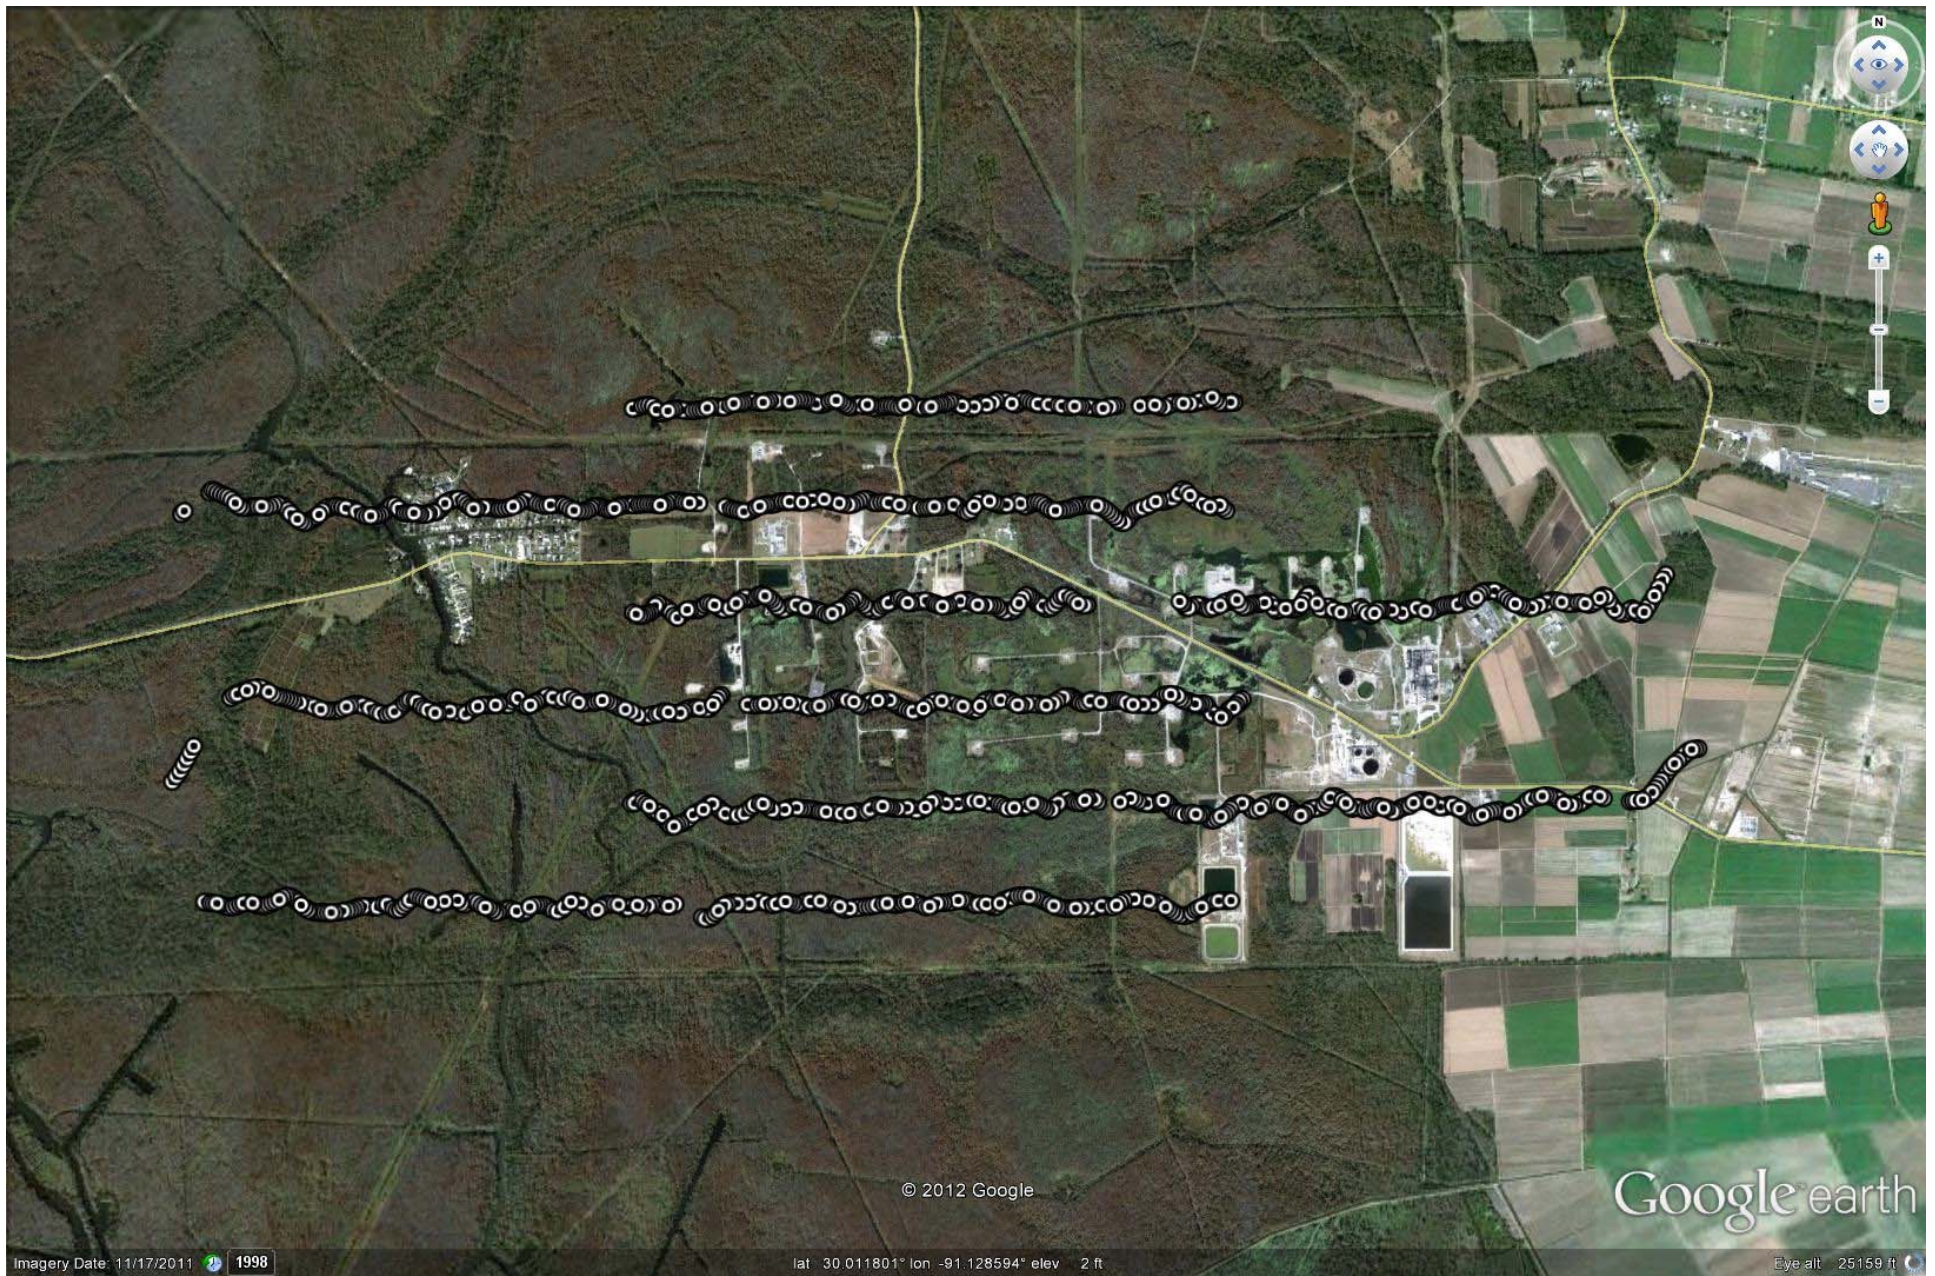
Chemical scan results

72 Chemicals built into the ASPECT automated detection algorithms

ASPECT was dispatched to conduct a chemical, radiological and photographic survey over and surrounding the Corne Bayou sinkhole and arrived on scene at 1350 on August 25, 2012. A total of 16 FTIR data collection passes were conducted over the area with none showing detectable concentrations of natural gas (methane) or other compounds contained in the ASPECT library.

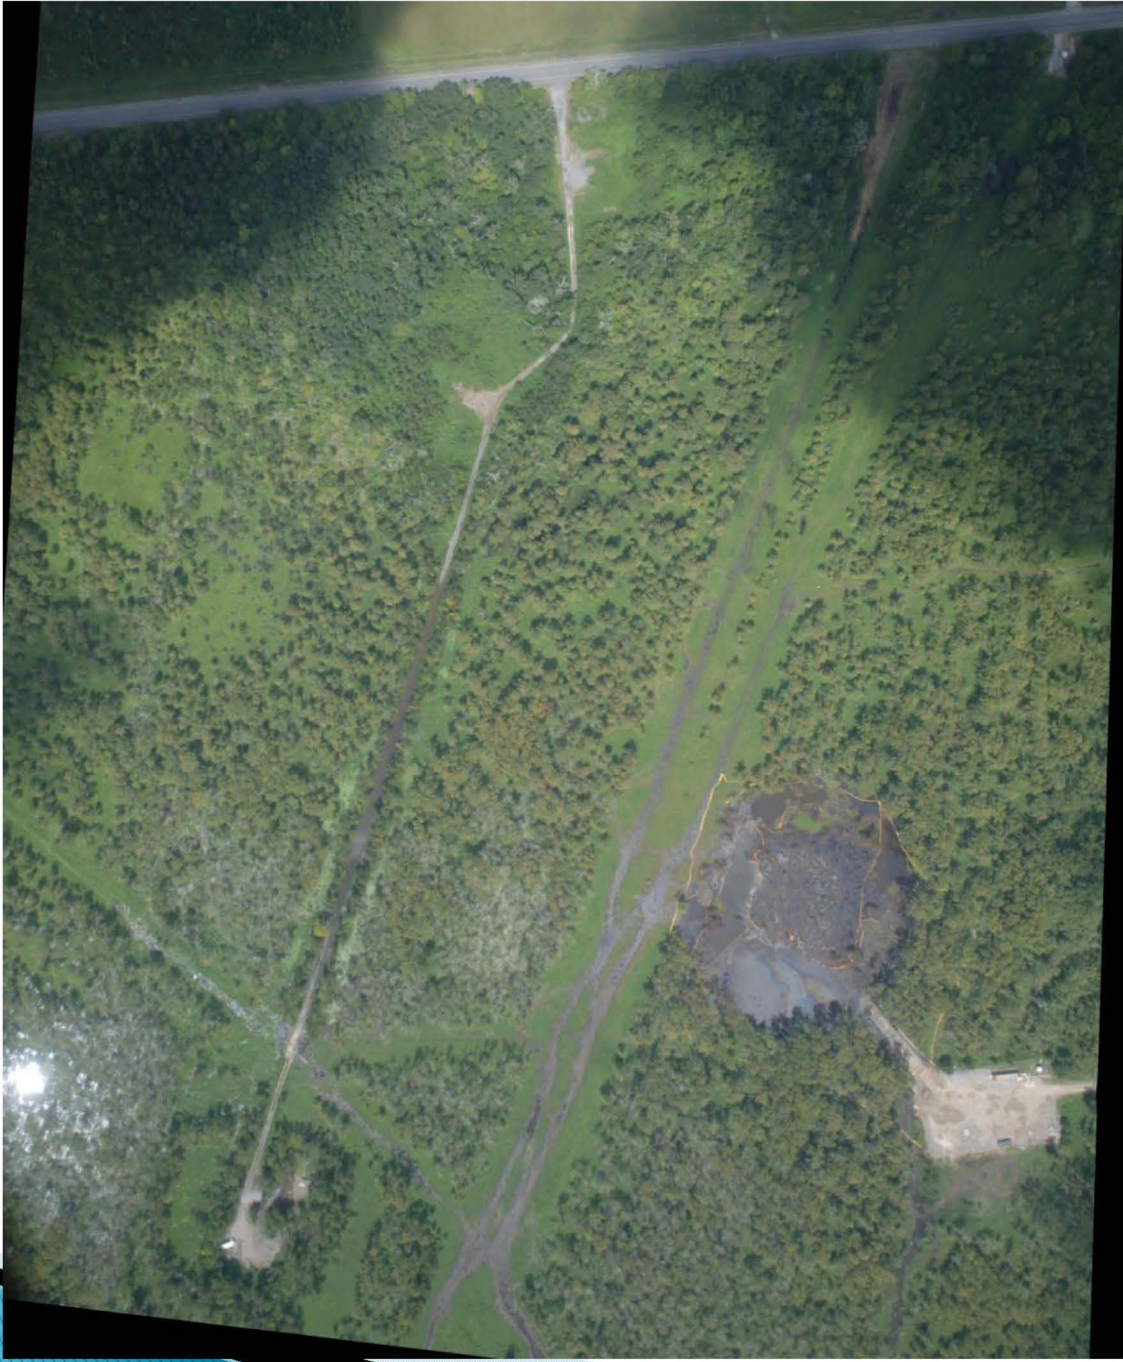
An Infrared Image

16 infrared images were collected over the survey area and did not show any chemical signatures or plumes being emitted from the sinkhole. It was noted that the infrared character of the water surface over the sinkhole is different than the surrounding water in the swamp suggesting that a petroleum film is present on top of the water in the sinkhole.
